## 3809 REPORT OF INSPECTION

S/047/048

Serial no. of notice: UTU 66354 (Haslem project area) Is the operation active? No (expired)

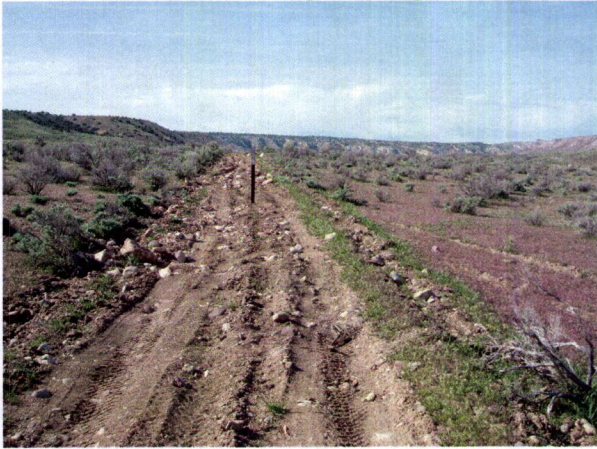
< image 1 view to south of former 6654 access that is signed as "closed" (on post in middle image). A wider wheel based vehicle had driven off-road to right and rutted the ground, more recent ATV tracks are seen in the path of this old two-track (that was ripped in August 2004)

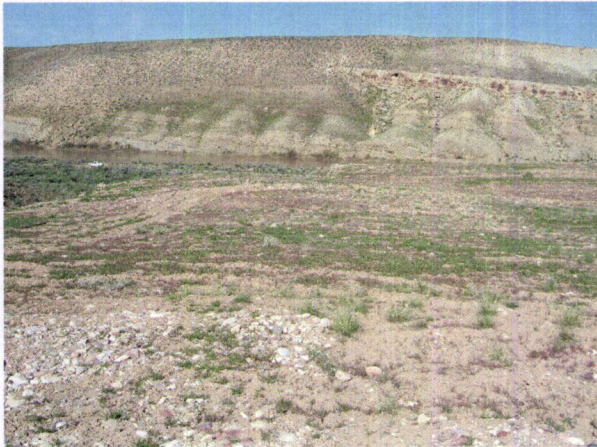
< image 2 view to west (from near SE corner of old project area), vehicular rutting along the south part of the reshaped area is at left in image (rutting continues along west side of reshaped 66354 area (northward past the signs in images 6 and 1) and southward across reshaped [expired notice area] UTU66358. Emerging noxious thistle or knapweed is toward the center of the image.

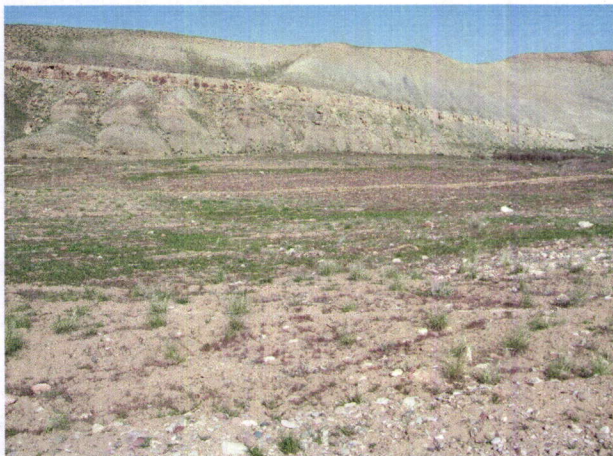
< image 3 view to west-northwest (pan to the right of image 2. Vehicular rutting runs left to right in the image. The reshaped area is mostly from the rutted area to the lower part of the image. A more cobbly area is coming into view at the left side of the image.

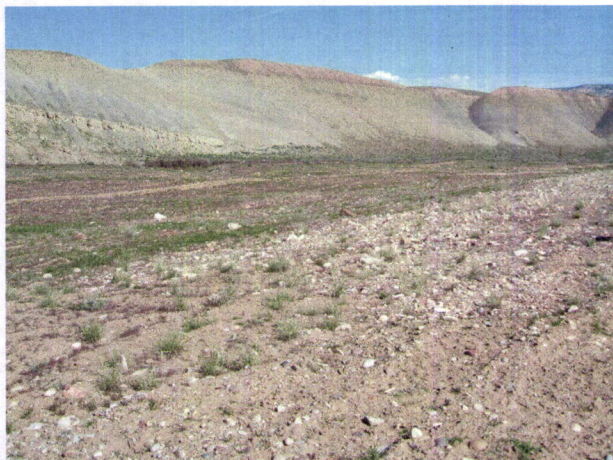
< image 4, view to northwest (pan to the right of image 3 above. Rutting is still evident from left to right. Area of sparsely vegetated cobble is at right.

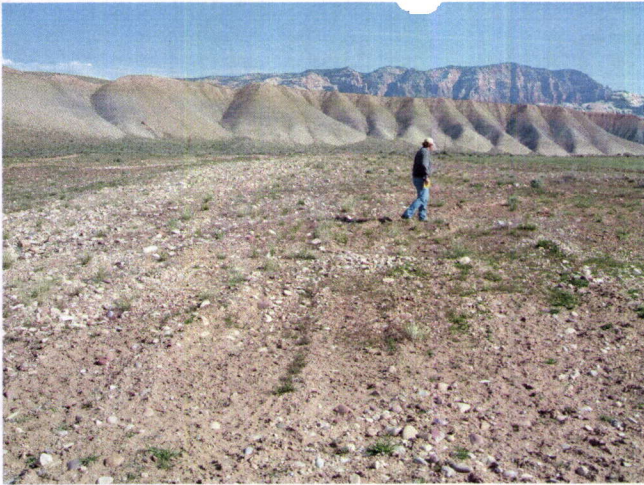
< image 5 view to north (pan to the right of image 4 above) looking at eastern and northern part of reshape area.

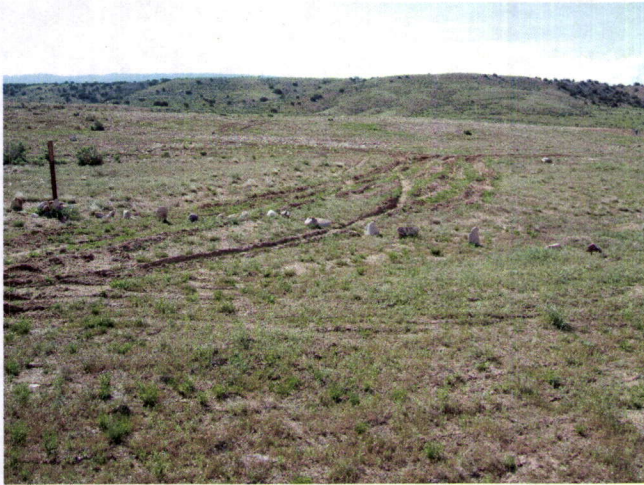
< figure 6 view to southeast (from outside the northwestern part of the reshaped project area. Two-track trail access to the project area was from the left. "Reclaimed area, no vehicular traffic" sign is posted at left (where the access entered the project area; vehicles drove around and rutted the ground. Majority of reshaped area is from upper left to right in image.

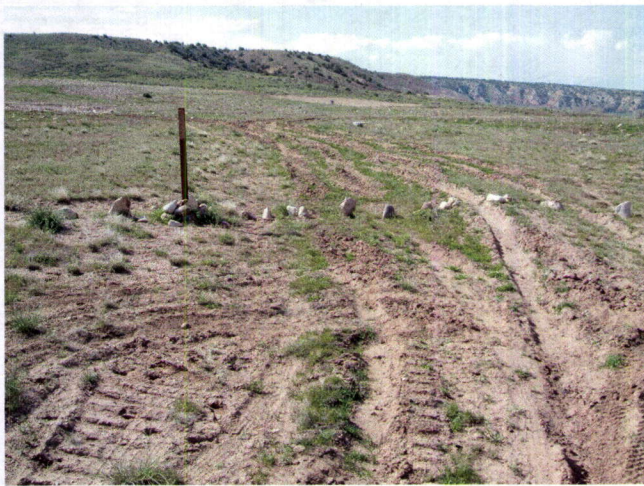
< figure 7 view to south of rutting that went around the west side of the sign posted (same as in the left side of image 6)
